Aerogel Insulation Stops Pipe Heat Loss, Improves Safety in Tight Spaces

Thin insulation avoids damage during pipe installation without cladding

CASE STUDY

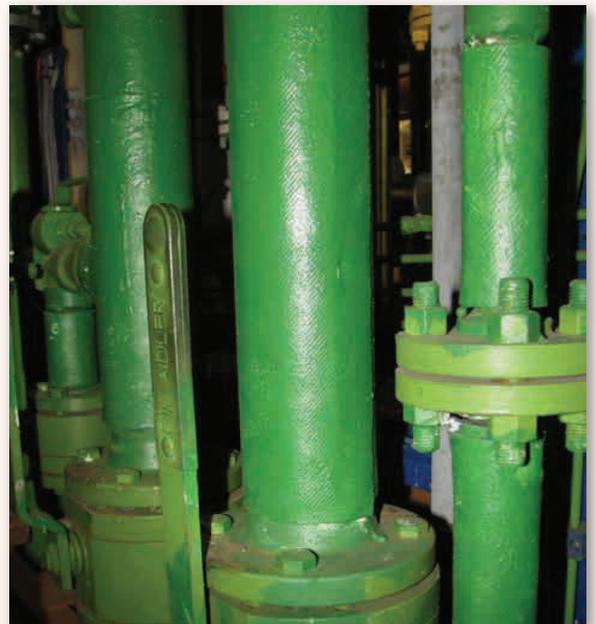
ABOVE: The Pyrogel insulation was easily painted — gray for gas, green for hot water — to identify the fluid in the piping.

- Agosti Isolazioni Termiche installed an aerogel solution of two layers of 4 mm Pyrogel® 4250 using a specifically chosen adhesive that was tested prior to installation.
- The external surface was covered with layers of varnish that were tested prior to installation.

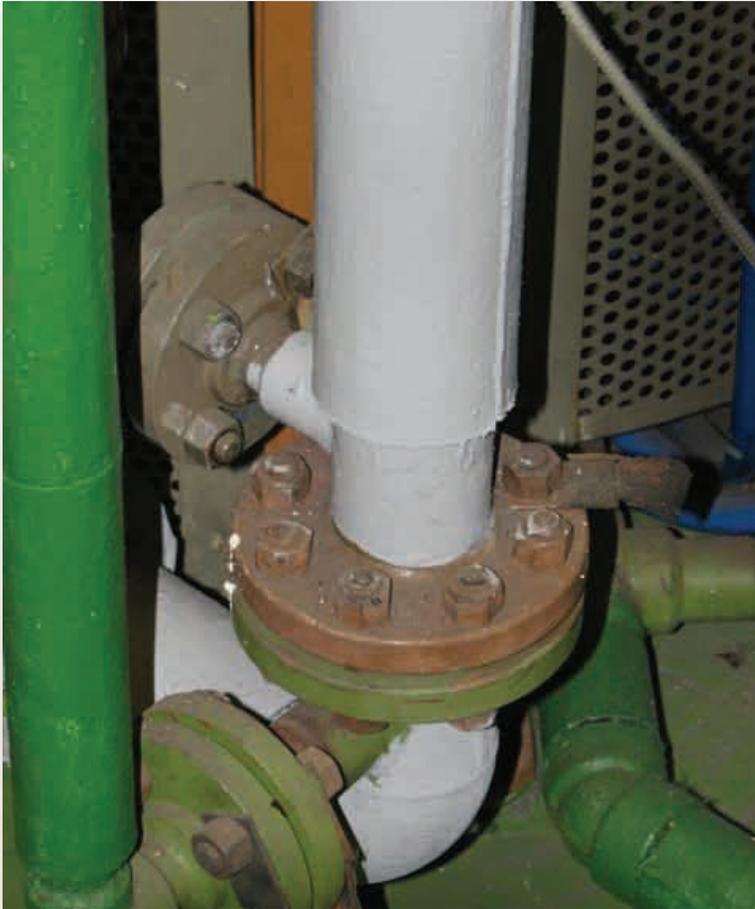
LEFT: Operators work continuously in the web of pipes, often coming into contact with them. Aerogel insulation reduced the touch temperature to safe levels, dramatically reducing the risk of injuries.

- The end user observed a dramatic reduction of the external surface temperature with only an 8 mm insulation thickness, reducing heat loss and energy consumption significantly.
- The insulation was thin enough to avoid damage during pipe mounting/dismounting, with no metallic cladding required.
- The insulation was applied directly on the pipes, saving valuable time during mounting and dismounting.
- The insulation noticeably improved operator working conditions near the hot pipes.

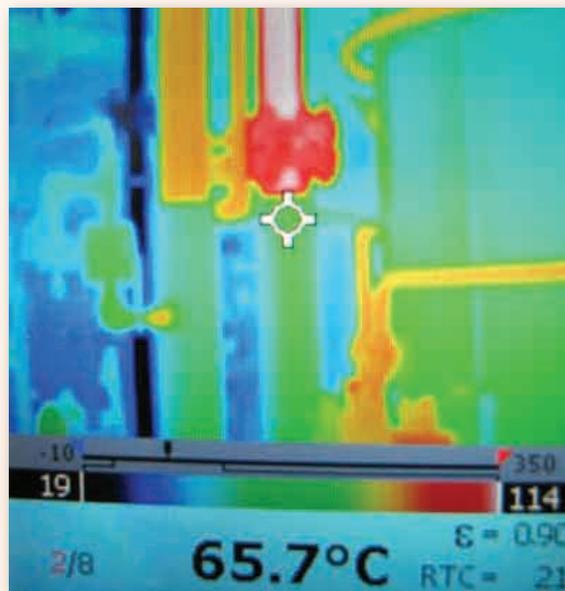
RIGHT: Thermal imaging shows a safe surface touch temperature after Pyrogel 4250 is applied.

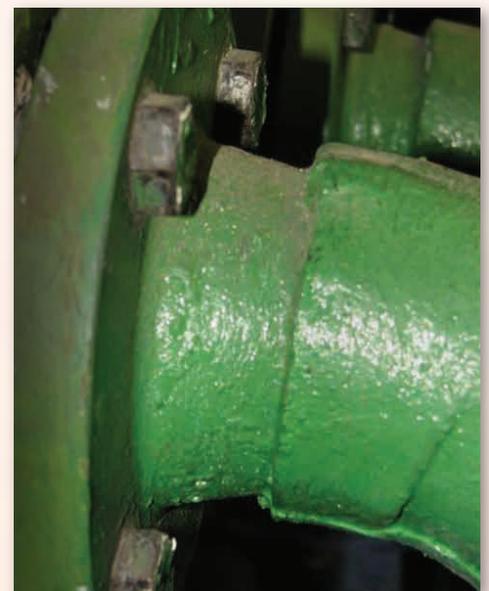
FAR RIGHT: The finished, painted surface protects the insulation during standard operations with no metallic cladding required.
